LAMONT GEOLOGICAL OBSERVATORY
(Columbia University)
Palisades, New York

CABLE FAILURES IN THE GULF OF CORINTH: A CASE HISTORY

Bruce C. Heezen, Maurice Ewing, and G. L. Johnson

The Bell Telephone Laboratories
Murray Hill, New Jersey
July, 1960

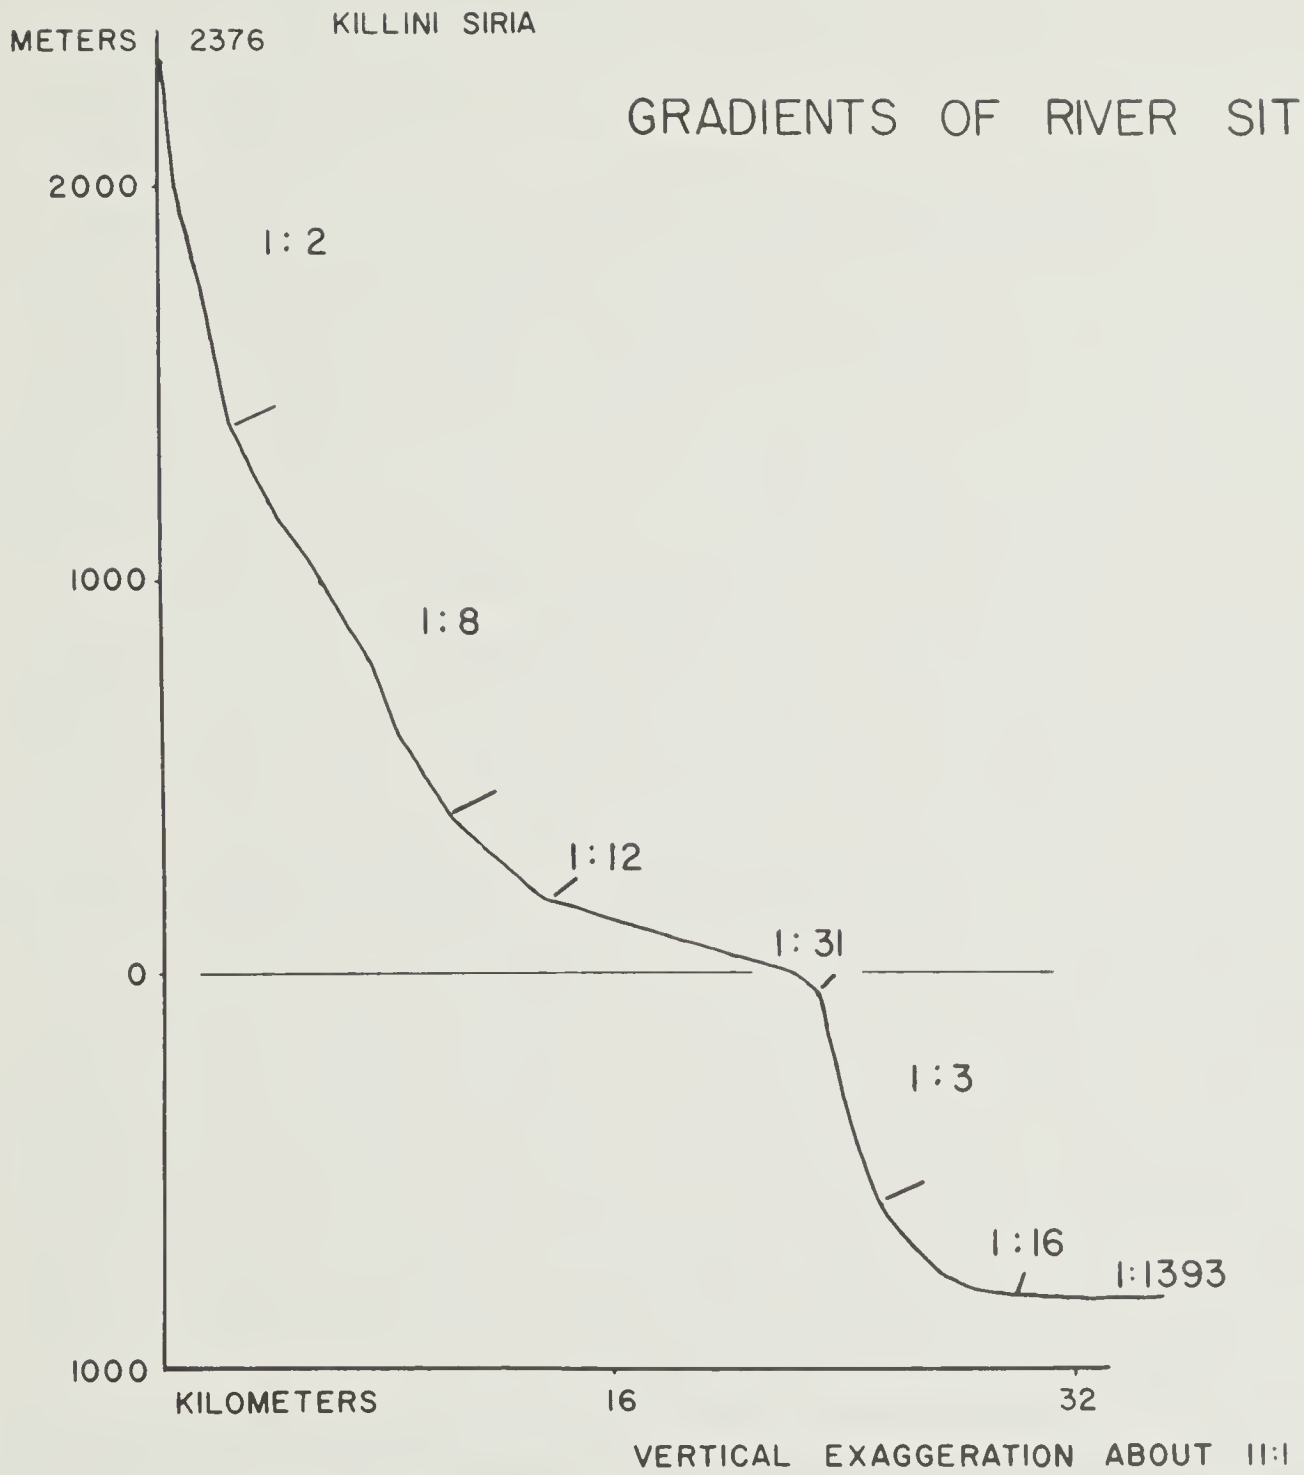
Fig. 26 Long profile of River Sithas and Sithas Submarine Canyon.

There are numerous mountain streams which flow into the gulf from the surrounding mountains with steep gradients (e.g., Fig. 26). During the dry summer months these streams are reduced to hardly a trickle; however, during heavy rainfalls they become raging torrents. The spring thaws in the mountains in March and April produce destructive floods. Turbidity currents frequently triggered at the river mouths during the floods account for many of the cable failures along the continental slope.

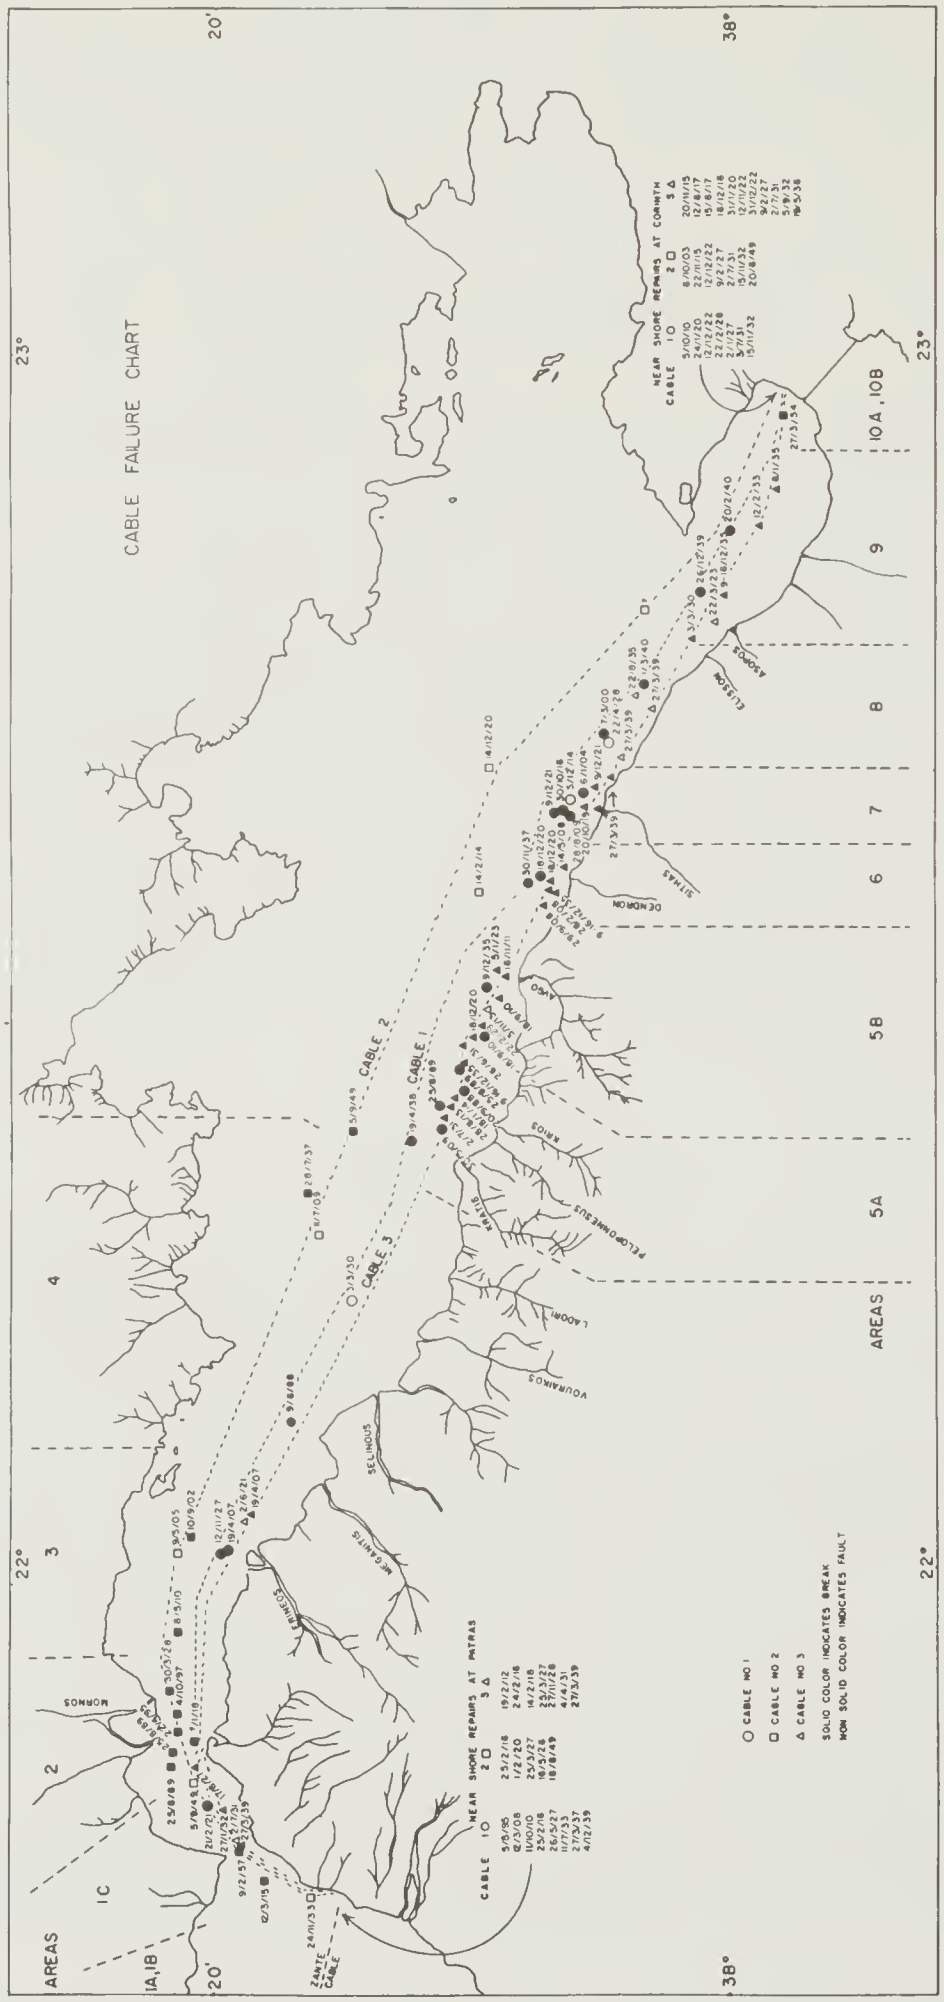
Fig. 32 Location and dates of all breaks and faults to cables 1, 2 and 3 between Corinth and Patras.

The northernmost cable, #2, laid in May 1884, passes along the northern side of The Narrows, directly down the continental slope, and across the abyssal plain to the Bay of Corinth. Cable #1 passed through the center of The Narrows and along the narrow continental rise and lower continental slope of the south side of the gulf. The southernmost cable, #3, laid in 1901, ran along the continental slope and shelf close to the south shore of the gulf. Of the three cables, #2 had the fewest failures and for that reason is the only one of the cables still in service. Cables #1 and #3, which failed in about equal numbers, were not renewed after World War II.

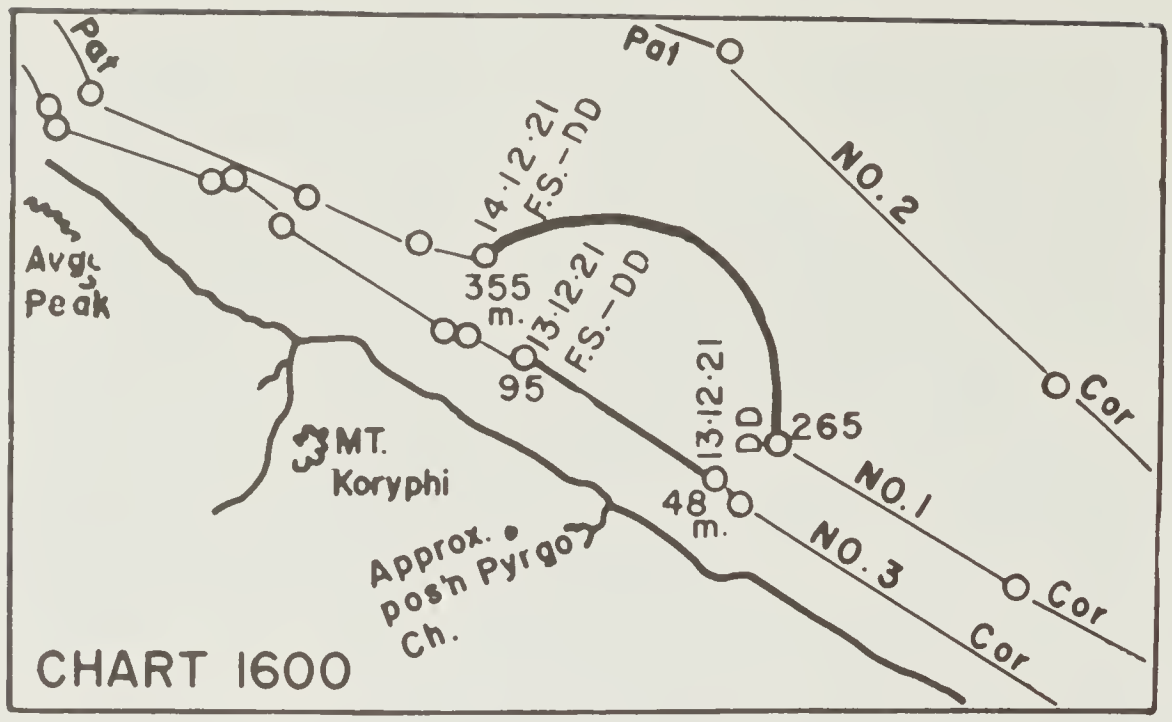
Fig. 33 Cable repair diagram sheet for Table IV.

Description and Cause of Defect:	Break	Submarine Landslide
Depth of Water in Fathoms:	265	355
Nature of Bottom:	mud & clay	mud & clay
Distance of First Splice:	15/13-12/13t	from Corinth, 16.331 nauts.
Distance of Final Splice:	12/13-15/13t	from Patras, 53.414 nauts.
Present Length of Cable:	.....	77.295 nauts.

1:35 p. m.	Buoyed Patras 3 end. Soundings 95 m.
2:44 p. m.	Recovered to break 1. 207 nautical miles D 16/13, in poor and damaged state, owing to debris from torrents. The break was caused by the usual submarine landslide, originated by the heavy torrents from mountain water-courses.
4:00 p. m.	Set on for shelter at Corinth. Northerly weather very fresh.
6:55 p. m.	Arrived.

We consider, however, that when cable is available and repairs are necessitated in this vicinity, that extensive diversions to the numbers 1 and 3 sections should be effected and thus eliminate the frequent interruptions which are invariably caused by the torrents.

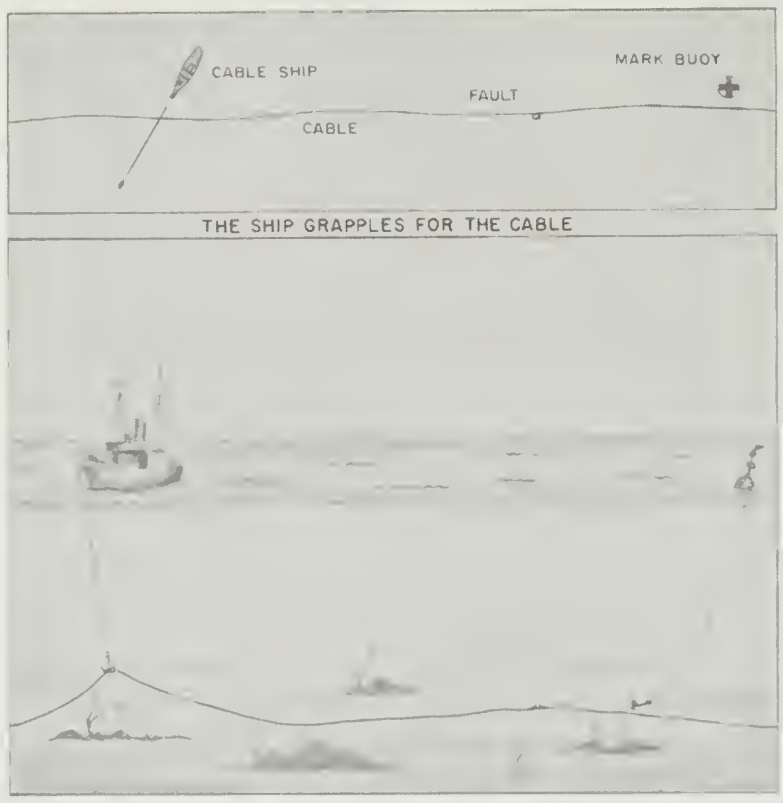
Fig. 35 **Cable ship grappling for cable.**

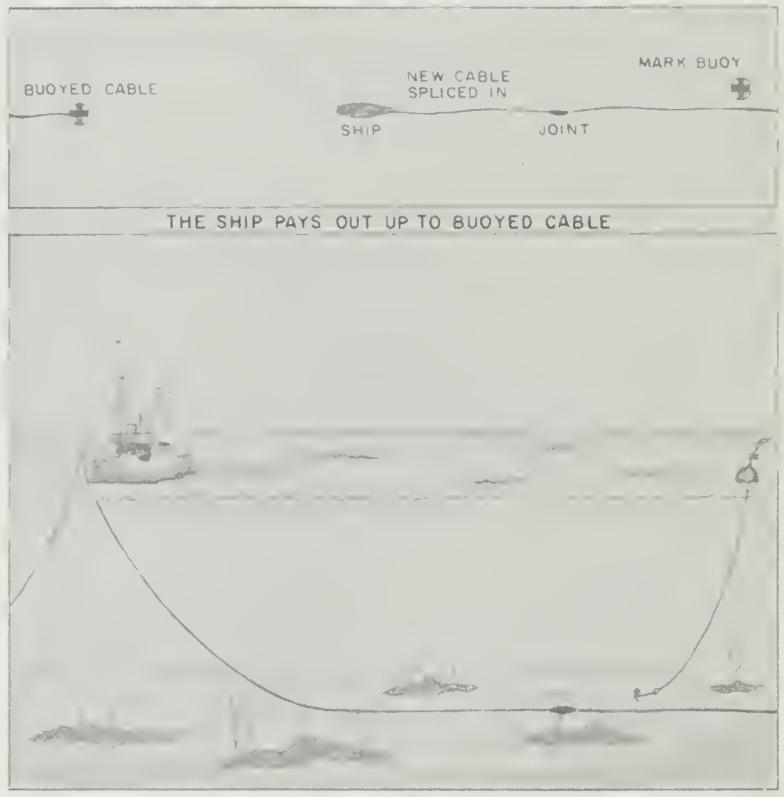
Fig. 37 Cable ship paying out new cable to final splice.

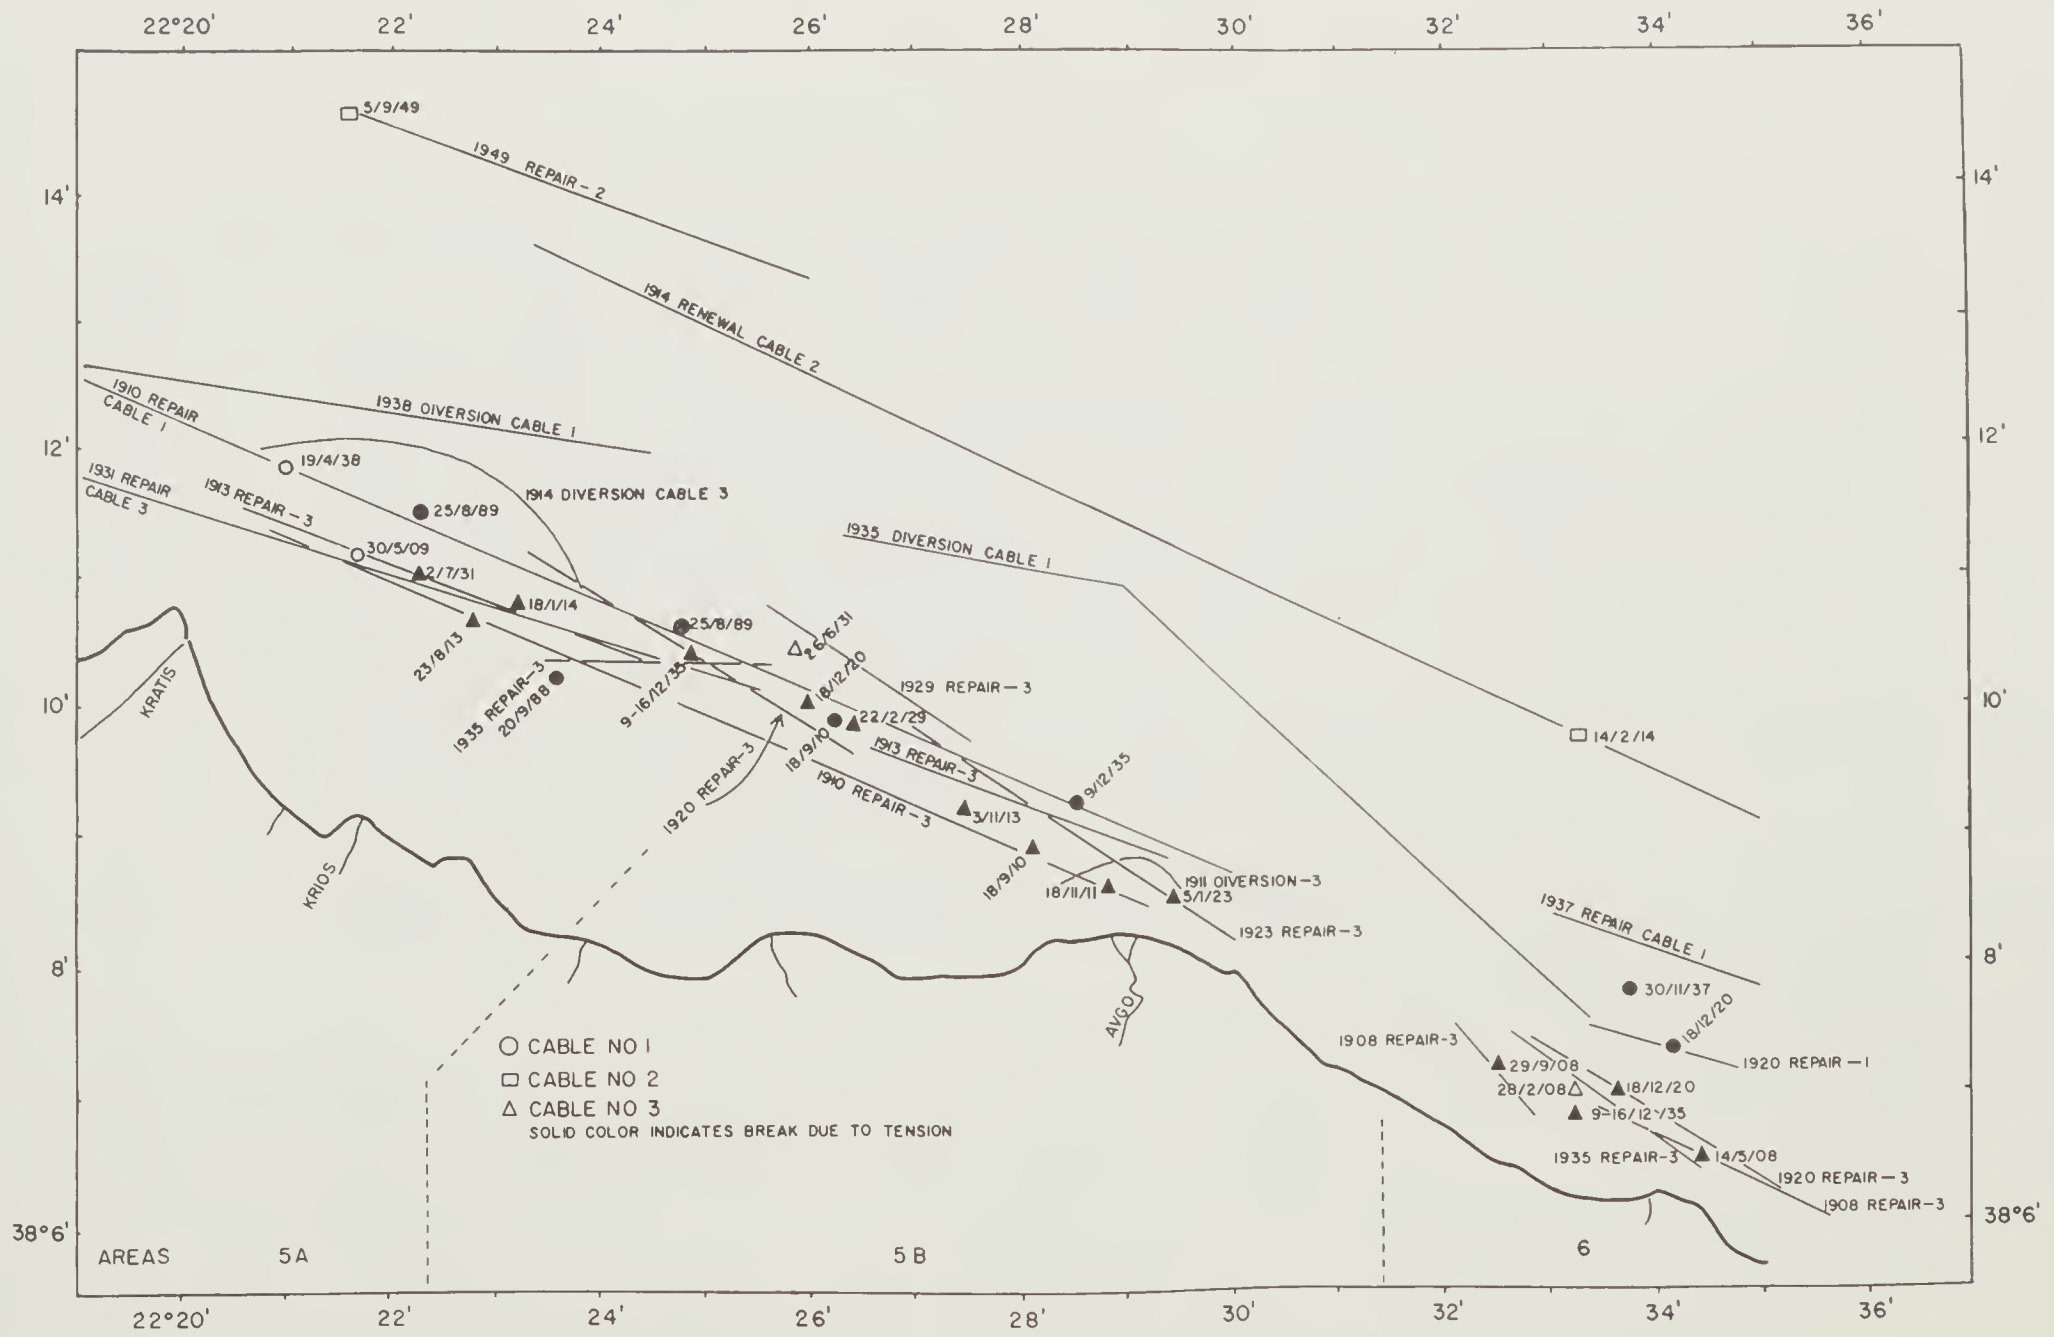
Fig. 39 Location of all cable failures and cable repairs in areas 5A, 5B and 6.

Continental Slope Seaward of the Avgó River, Area 5B. (See Table X and Figs. 32 and 39.) There have been eight failures in this area. Seven are clearly due to turbidity currents or slumping. The fault repaired on 3/11/13 is most likely related in cause to the other seven. All these failures occurred from September to February, which corresponds well with the maximum precipitation (Fig. 23). The failures are aligned in a NW and SW pattern along one large canyon. At 1630 L.M.T. on the 18th of September 1910, both cables 1 and 3 were broken. They must have been broken by one large flow down the axis of the canyon. On all other occasions, however, only one of the two cables broke. Cable #3, which lay closer to the mouth of the Avgó, failed five more times, but cable #1 failed only once again, during the December 1935 storms. Cable #3 possibly escaped injury in 1935 because it was newer and therefore stronger than the #1 cable, but it may have been buried; or lacking obstructions or brush entanglements, the flow could have swept over it without breaking it.

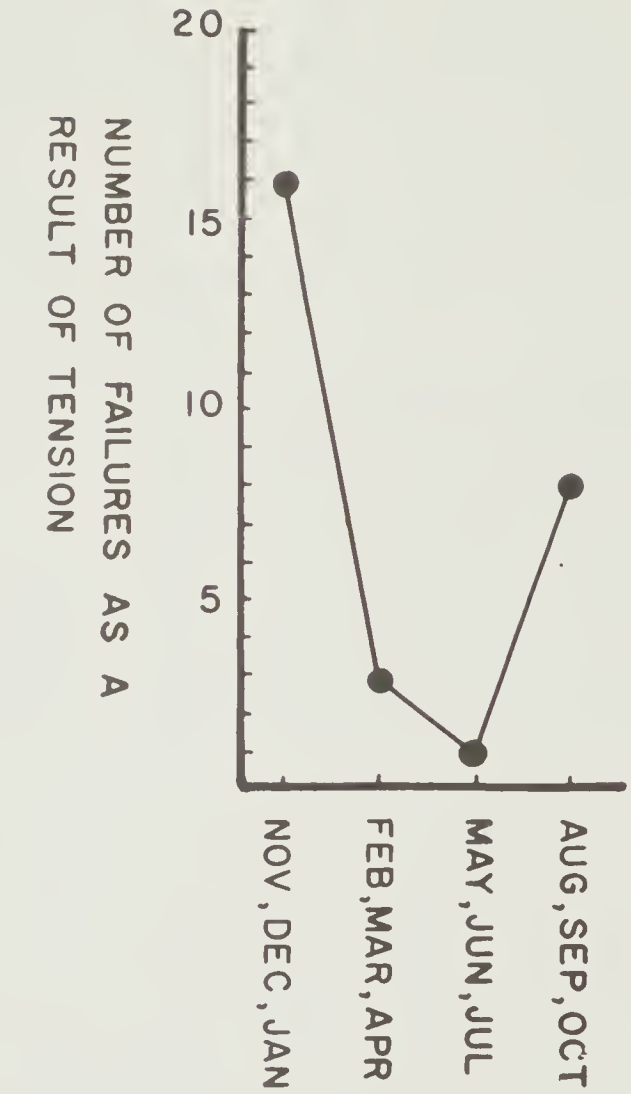
Fig. 41 Seasonal distribution of tension breaks.

Turbidity currents and slumps; breakage of cables. There are many mountain streams which empty into the Gulf of Corinth, and during times of flood these streams carry a heavy load of sediment and debris. As one can see from examining Tables V-XIV, there are many cases in which branches, twigs and brushwood of various kind have been found wrapped around the broken cable. As can be seen from Fig. 41, there is a tendency for cable failures due to turbidity currents or slumps to occur during the winter months, with November, December, and January as the peak months. The high incidence of winter breaks corresponds to the season of maximum precipitation for the area (Fig. 23). The December 1935 breaks occurred during the first heavy winter gales. The repair ship log also notes: "Several torrents and one mountain river debouch in the gulf in the immediate vicinity carrying, especially

during the winter gales of rain and hail, a vast quantity of alluvium into the sea." In all, the cable ship repair logs list a total of 28 breaks as due to submarine displacement or tension.
